# Manhole Inspection Summary

Manhole # S35WW1015MH

**Location** Address: **314 BROADMOOR RD** Cross Street: **WILLOWMERE WAY**

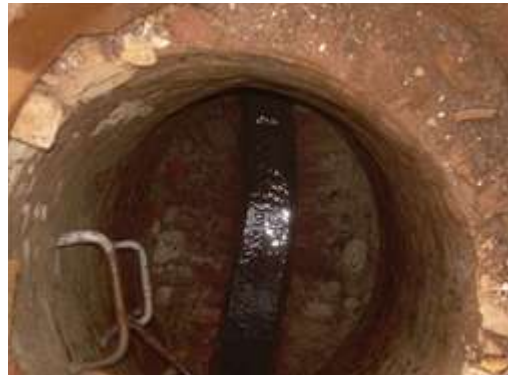
Top View

**Bench** ☒ Exists Material: **Brick** ☐ Parged ☒ **Debris** (not Condition related)  
Condition: ☒ Sound ☐ Cracked ☐ Root Intrusion ☐ Deteriorated ☐ Leaks ☐ Debris

**Steps** Count: **5** Missing: **0** ☒ **Corroded**

**Surcharge** ☒ **Evidence Of Surcharge** Depth: **1.5** (ft.) ☐ Active Surcharge Present

Corroded steps. Evidence of surcharge - Bench debris.

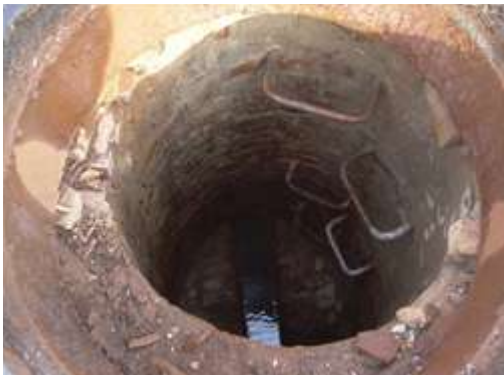
Defect

**Frame** Offset: **3** (in.) Condition: ☐ Sound ☐ Cracked ☒ **Leaks**

**Chimney / Frame Adjustment** ☒ Exists Material: **Brick** ☐ Parged Height: **15** (in.)  
Condition: ☐ Sound ☐ Cracked ☐ Root Intrusion ☒ **Loose Brick** ☒ **Deteriorated**  
Infiltration: ☐ None ☒ **Joint** ☐ Cracks ☒ **Mortar** ☐ Roots ☐ Wall

**Corbel** Material: **Brick** ☐ Parged Type: **Concentric/Eccentric**  
Condition: ☒ Sound ☐ Cracked ☐ Root Intrusion ☐ Loose Brick ☐ Deteriorated  
Infiltration: ☐ None ☐ Joint ☐ Cracks ☐ Mortar ☐ Roots ☒ **Wall**

**Barrel** Material: **Brick** ☐ Parged  
Shape: **Circular** Diameter: **42** (in.) Length: (in.)  
Condition: ☐ Sound ☐ Cracked ☐ Root Intrusion ☐ Loose Brick ☒ **Deteriorated**  
Infiltration: ☐ None ☐ Joint ☐ Cracks ☒ **Mortar** ☐ Roots ☐ Wall

Frame leaks. Frame offset. Adjustment deterioration, loose brick and infiltration. Corbel and Barrel infiltration - other side.

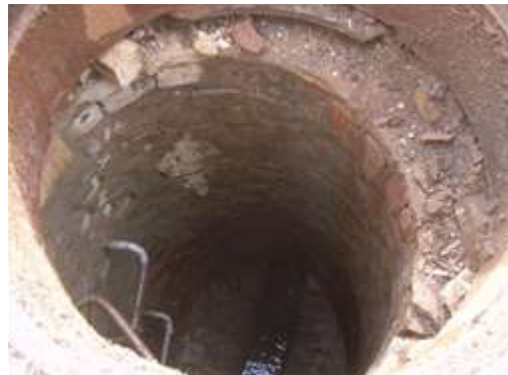
Defect

Frame leaks. Frame offset. Adjustment deterioration, loose brick and infiltration. Corbel and Barrel infiltration.

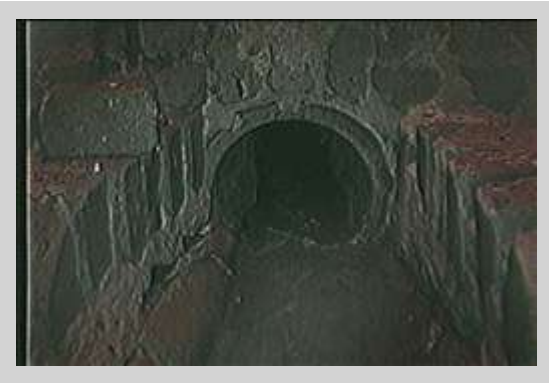
### 8 in. Circular Gravity Sewer Pipe Out @ 12 O'Clock

Barrel deterioration and infiltration. Channel deterioration.

Infiltration: **Evidence** Pipe Seal Cond: **Unknown**

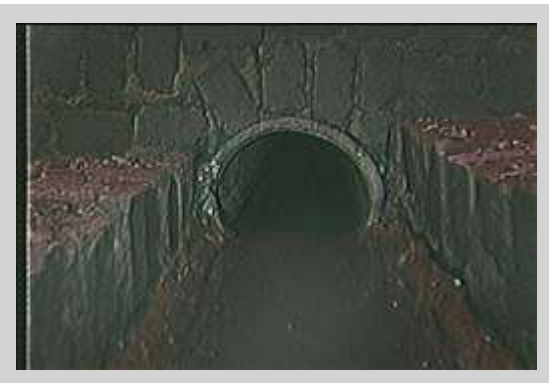
### 8 in. Circular Gravity Sewer Pipe In @ 7 O'Clock

Barrel deterioration and infiltration. Channel deterioration.

Infiltration: **Evidence** Pipe Seal Cond: **Cracked**
